# Site Accessibility Evaluation

**Wheeler Ridge Park**  
**3100 Lipizzan Dr**  
**Denton, TX 76210**

**Accessibility Evaluation**

***Inspection Date: 04/14/2021***  
***Inspector: N/A***

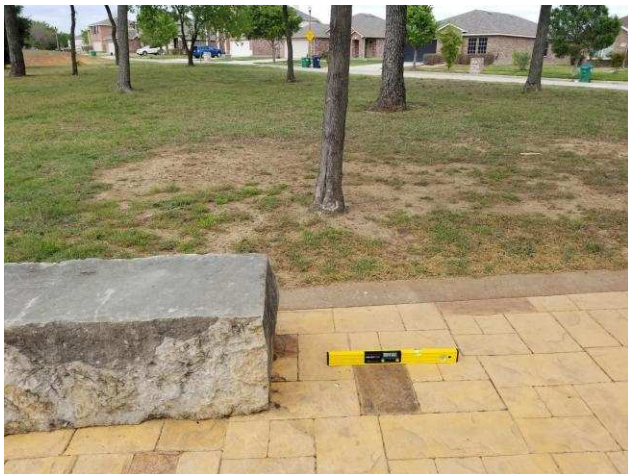
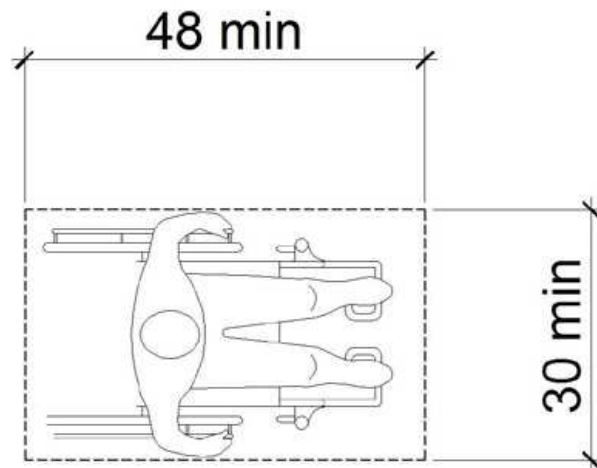
### Barrier: 1

The clear floor space required at the bench is not flat (2 percent or 1:48 maximum slope) in all directions.

2010 ADAS Section: 305.2

1991 ADAAG Section: 4.2.4.1

Level 7 (Medium): Access to goods and services (DOJ Level 2) – minimally out of compliance

Modify the clear floor space at the bench to provide a slope no greater than 2 percent in any direction.

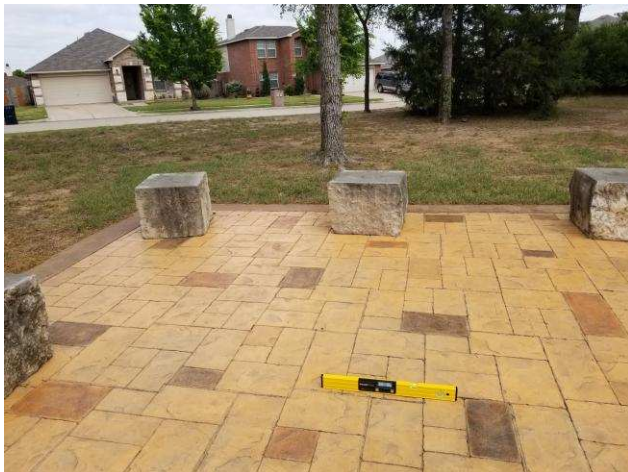
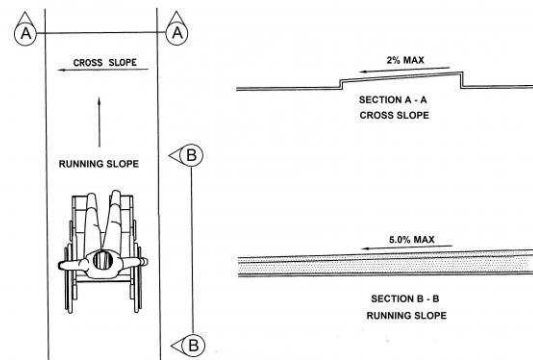
### Barrier: 2

The accessible path of travel has cross slopes greater than 2 percent.

2010 ADAS Section: 403.3

1991 ADAAG Section: 4.3.7

The accessible route of travel contains a cross slope of 3 percent.

Level 6 (Medium): Parking or exterior accessible routes (DOJ Level 1) – minimally out of compliance

Modify path of travel to achieve a cross slope that is no greater than 1:48 (2.08 percent).

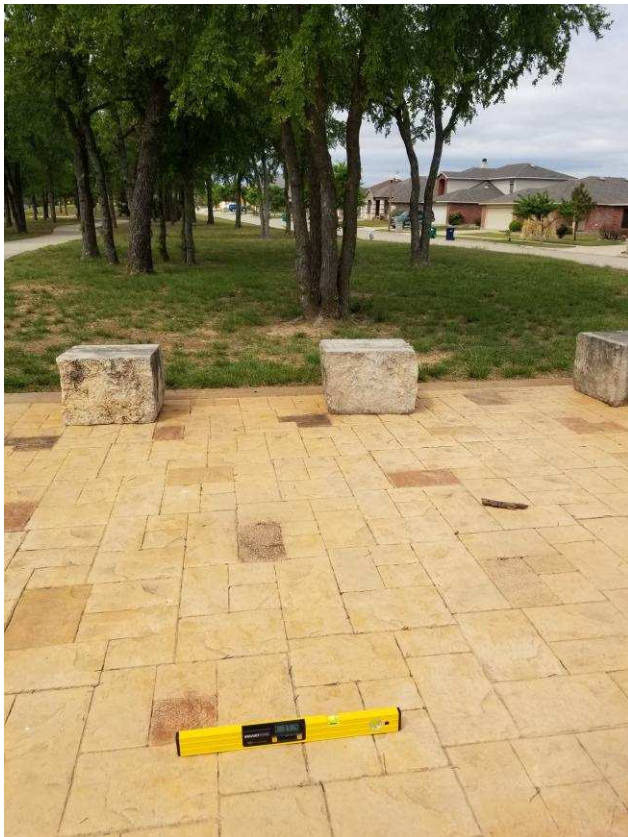
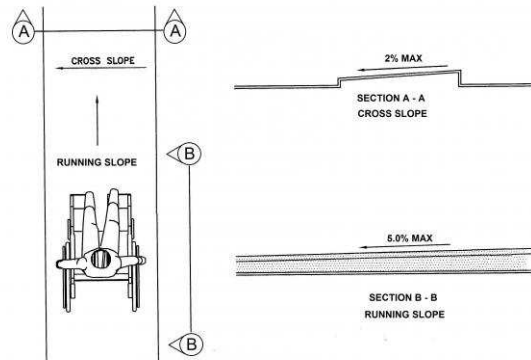
### Barrier: 3

The accessible path of travel has cross slopes greater than 2 percent.

2010 ADAS Section: 403.3

1991 ADAAG Section: 4.3.7

The accessible route of travel contains a cross slope of 3.7 percent.

Level 4 (High): Parking and exterior accessible routes (DOJ Level 1) – moderately out of compliance

Modify path of travel to achieve a cross slope that is no greater than 1:48 (2.08 percent).

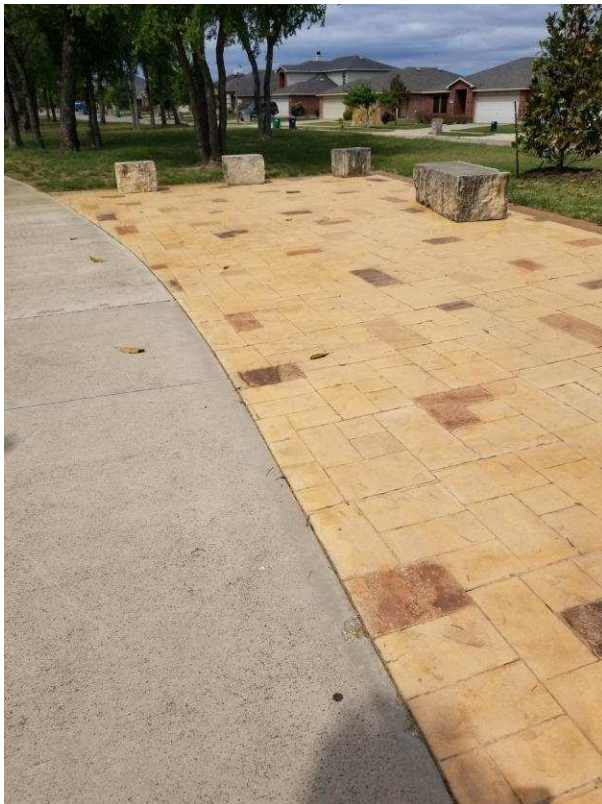
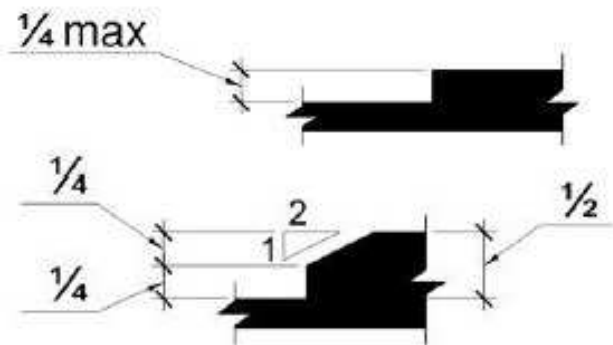
**Barrier: 4**

The walkway contains abrupt vertical edges and/or variations over 1/4 inch.

2010 ADAS Section: 303.3,  
303.2

1991 ADAAG Section: 4.5.2

The walkway contains  
abrupt vertical edges and/or  
variations over 1/4 inch

Level 6 (Medium): Parking or exterior accessible routes (DOJ Level 1) – minimally out of compliance  
Access to goods and services (DOJ Level 2) – moderately out of compliance  
Restrooms (DOJ Level 3) – severely out of compliance

Modify the connection between the trail and seating area to provide a smooth level surface.

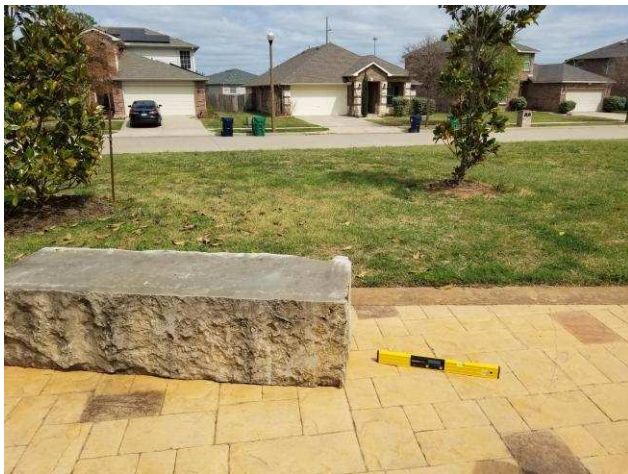
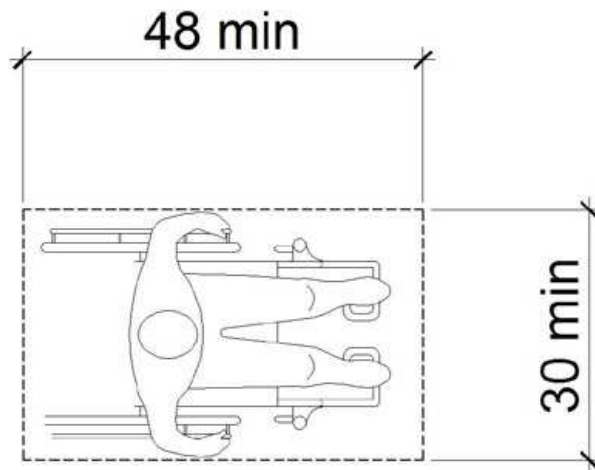
### Barrier: 5

The clear floor space required at the bench is not flat (2 percent or 1:48 maximum slope) in all directions.

2010 ADAS Section: 305.2

1991 ADAAG Section: 4.2.4.1

Level 7 (Medium): Access to goods and services (DOJ Level 2) – minimally out of compliance  
Restrooms (DOJ Level 3) – moderately out of compliance  
Drinking fountains and public phones (DOJ Level 4 & 5) – severely out of compliance

Modify the clear floor space at the bench to provide a slope no greater than 2 percent in any direction.

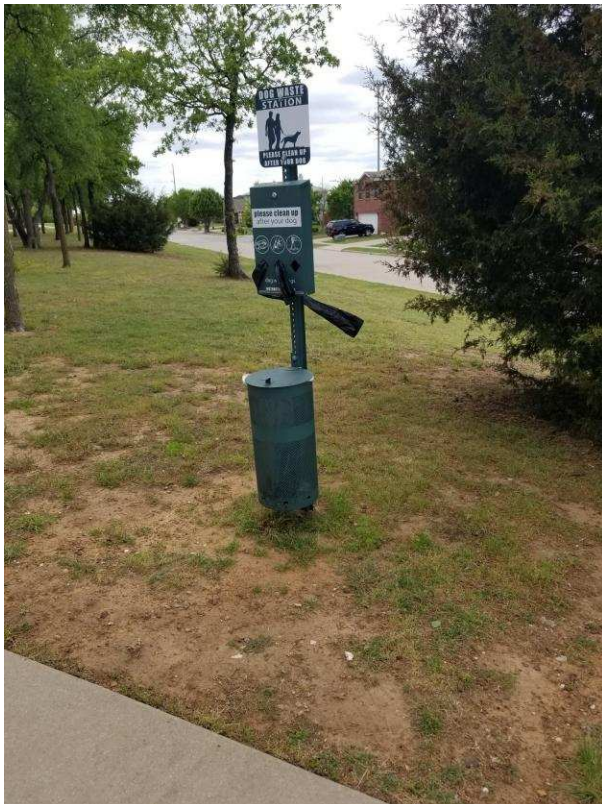
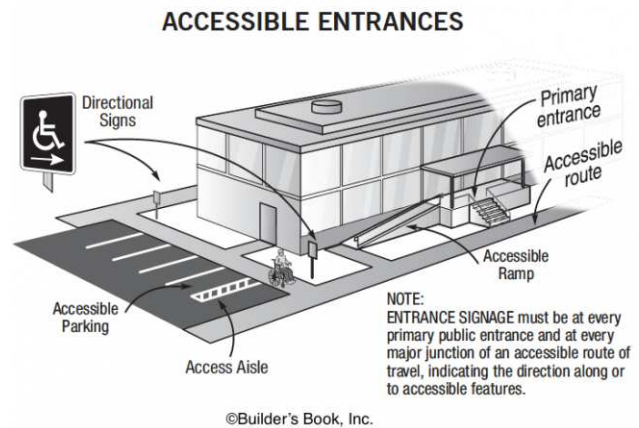
**Barrier: 6**

There is no accessible route to the dog waste dispenser.

2010 ADAS Section: 206.2.2

1991 ADAAG Section:  
4.1.2(1)

Level 7 (Medium): Access to goods and services (DOJ Level 2) – minimally out of compliance  
Restrooms (DOJ Level 3) – moderately out of compliance  
Drinking fountains and public phones (DOJ Level 4 & 5) – severely out of compliance

Provide an accessible route to the dog waste dispenser.

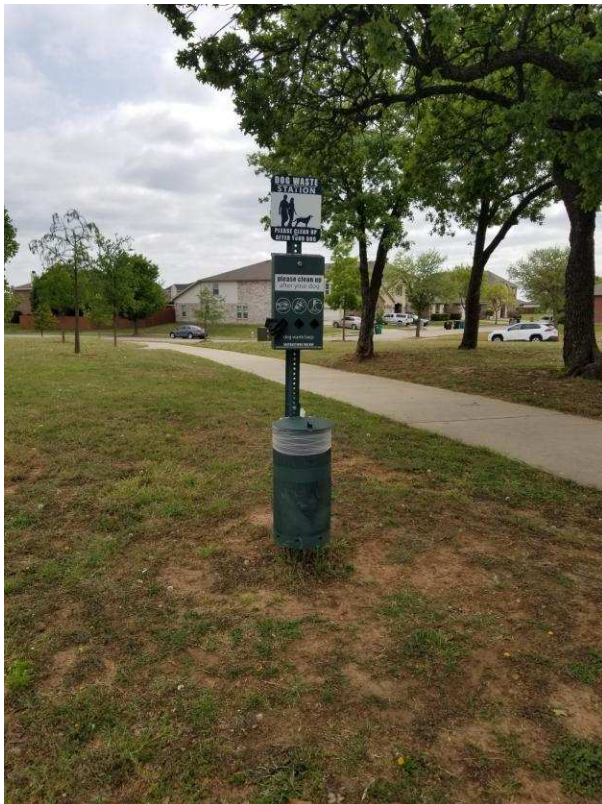
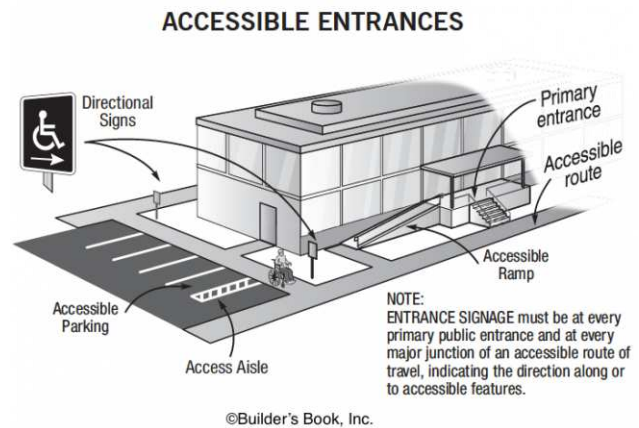
### Barrier: 7

There is no accessible route to the dog waste dispenser.

2010 ADAS Section: 206.2.2

1991 ADAAG Section:  
4.1.2(1)

There is no accessible route  
to the dog waste dispenser.

Level 7 (Medium): Access to goods and services (DOJ Level 2) – minimally out of compliance  
Restrooms (DOJ Level 3) – moderately out of compliance  
Drinking fountains and public phones (DOJ Level 4 & 5) – severely out of compliance

Provide an accessible route of travel to the dog waste dispenser.
