# Site Accessibility Evaluation

**Industrial Park**  
**108 Industrial St**  
**Denton, TX 76201**

**Accessibility Evaluation**

***Inspection Date: 04/16/2021***

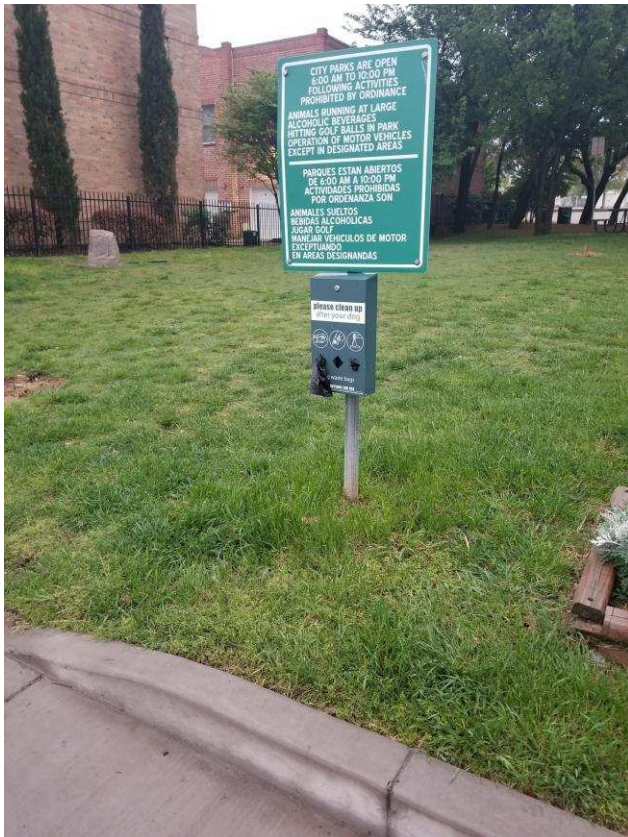
### Barrier: 1

There is no accessible route to the dog waste bag dispenser.

2010 ADAS Section: 206.2.2

There is no accessible route  
to the dog waste bag  
dispenser.

Level 5 (Medium): Access to goods and services issues (DOJ Level 2) – severely out of compliance

Provide an accessible route of travel and the required clear floor space to the dog waste bag dispenser.

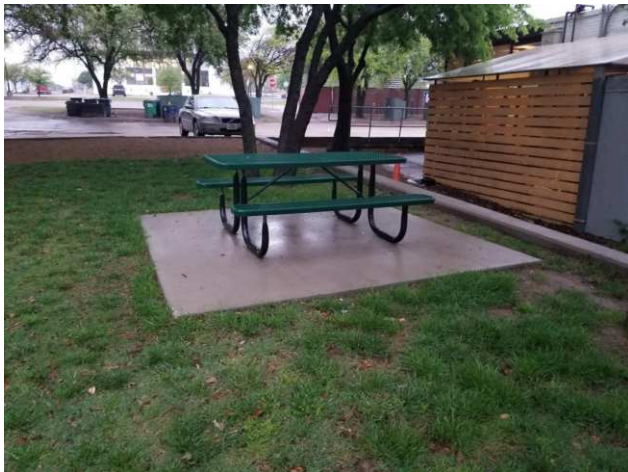
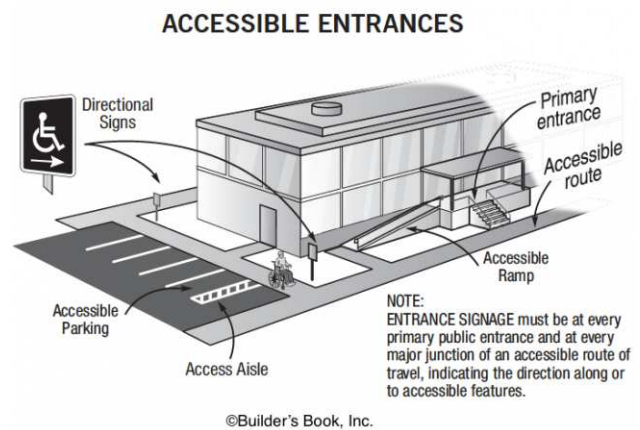
### Barrier: 2

There is no accessible route to the table.

2010 ADAS Section: 206.2.2

Level 6 (Medium): Parking or exterior accessible routes (DOJ Level 1) – minimally out of compliance  
Access to goods and services (DOJ Level 2) – moderately out of compliance  
Restrooms (DOJ Level 3) – severely out of compliance

Provide an accessible route of travel to the table.

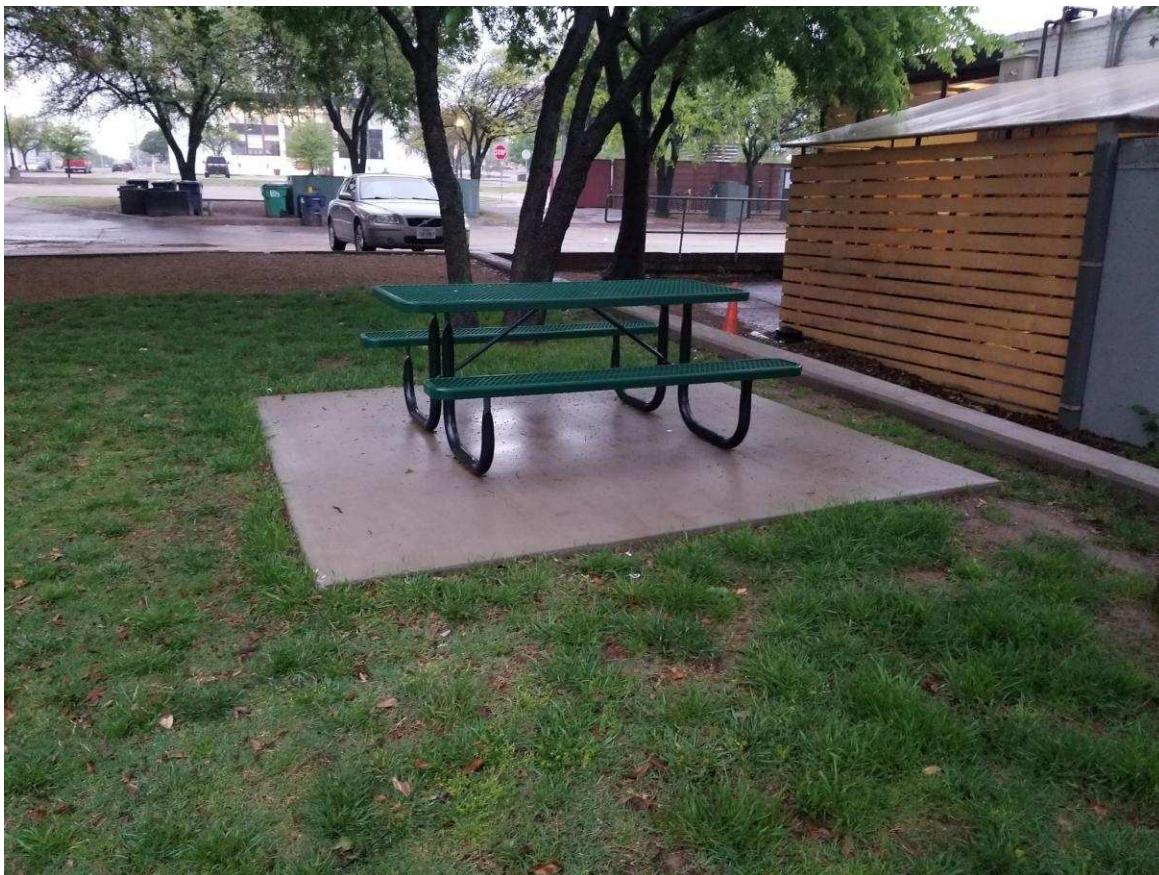
**Barrier: 3**

There are no accessible tables.

2010 ADAS Section: 226.1

Level 5 (Medium): Access to goods and services issues (DOJ Level 2) – severely out of compliance

Provide an accessible table at the park.

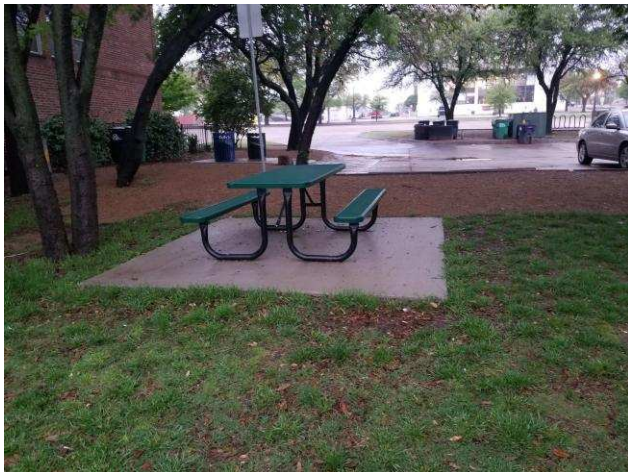
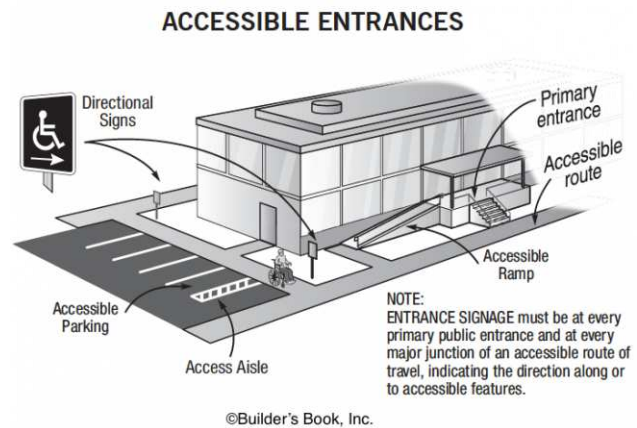
### Barrier: 4

There is no accessible route to the table.

2010 ADAS Section: 206.2.2

Level 6 (Medium): Parking or exterior accessible routes (DOJ Level 1) – minimally out of compliance  
Access to goods and services (DOJ Level 2) – moderately out of compliance  
Restrooms (DOJ Level 3) – severely out of compliance

Provide an accessible route to the table.
